**Survey of items**

## 94 Body noises

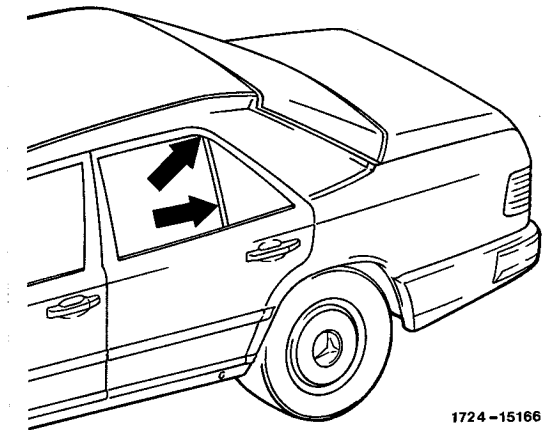
1724-15166

94-87051 Wind noises in area of window sill of rear door.

1. Window guide rail is insufficiently held in window sill.
2. Poor fit of window guide rail at top in corner of window sill.

1. Install modified window sill (with additional profile on the inside of the crank-operated window and on the outside of the quarter window.

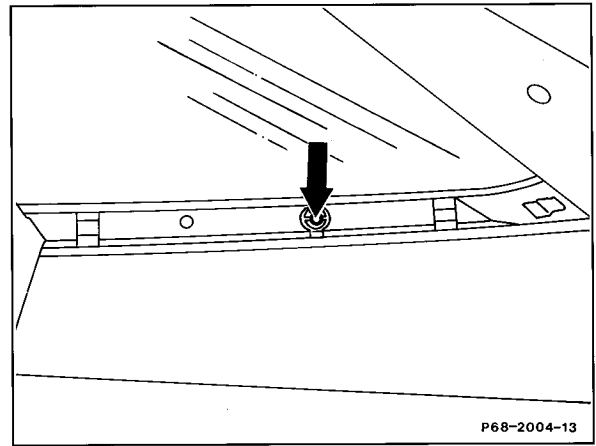
94-88101 Clicking noises in area of rear pillar between plastic molding and fender.

Bottom edge of plastic molding resting on rear fender.

Install rubber buffer, part no. 201 987 02 39, under plastic molding (arrow).

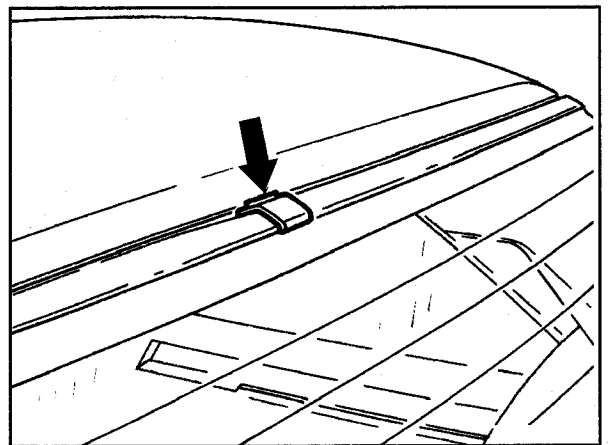
94-90101 Clicking noises from area of rear window while driving on rough roads.

Cover over the joint of the trim moulding on rear window is loose.

Install modified cover, part no. 124 678 42 37 (inside of cover is teflon-coated).
