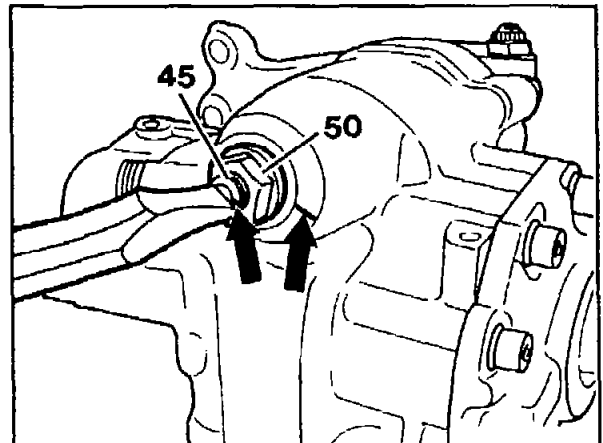
P46-2047-13

Oil escape at steering gear adjusting screw

Polyamide ring on the lock nut does not seal sufficiently.

Replace lock nut, part no. 001 990 70 51.

- 1 Mark position of adjusting screw by notches (arrows).
 - 2 Replace lock nut without turning the adjusting screw.
- Tighten lock nut to 65 Nm.

If the adjusting screw was turned, readjust friction torque of steering gear (refer to Repair Instructions 46-3230).

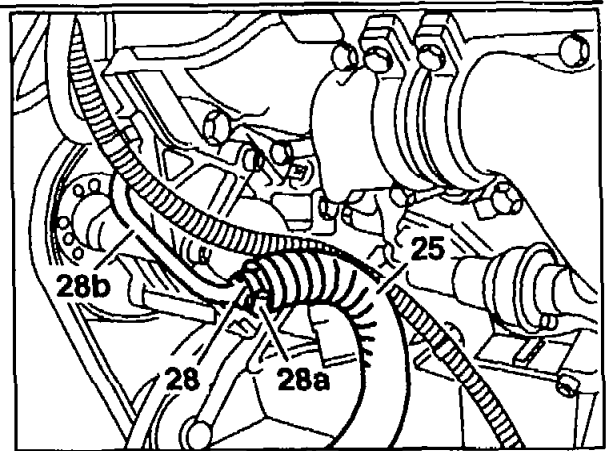
P46-2602-13

Oil return hose of power steering leaking

Oil return hose (28) is not correctly installed on the return pipe (28b) of power steering pump.

Push on oil return hose (28) up to the second shoulder of the return pipe (28b) and install hose strap (28a) between the first and second shoulder. Push heat shield (25) over the hose strap (28a) and compress.
