## 05-2200 Removing and installing camshaft

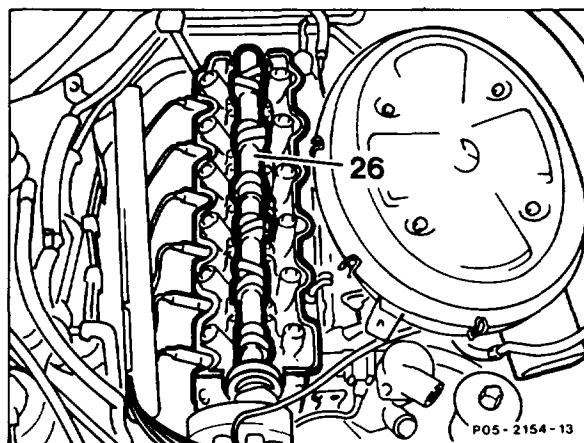
- 6 Lift out camshaft (26).

Pay attention to the thrust washer at the front (axial mounting) when lifting out camshaft.

- 7 Oil camshaft bearing journals.
- 8 install in the reverse order.
- 9 Check basic position of camshafts (05-2230).
- 10 Check oil supply (direction of spray) of camshaft at idle speed.
