All models

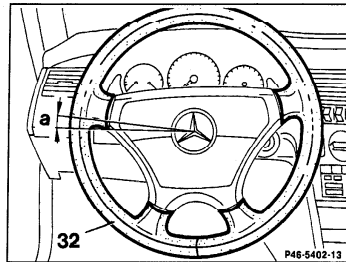
a = max. 25 mm

- In steering center position, maximum allowable play (a) at steering wheel is 25 mm.
